Report on field trip from 12th to 16th of June, 2017

1. Aims of the field trip:

- Validating the finding of Utilis in a pilot project;
- Making acquaintance to use Utilis's data in the field for leak detection (GIS files, Web application, leak sheets, data form);
- Getting use to the acoustic method which are using today for finding leakage;
- Developing relationship with other parties in the project.

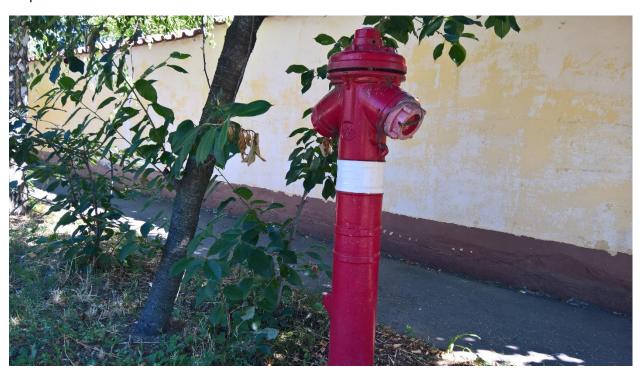
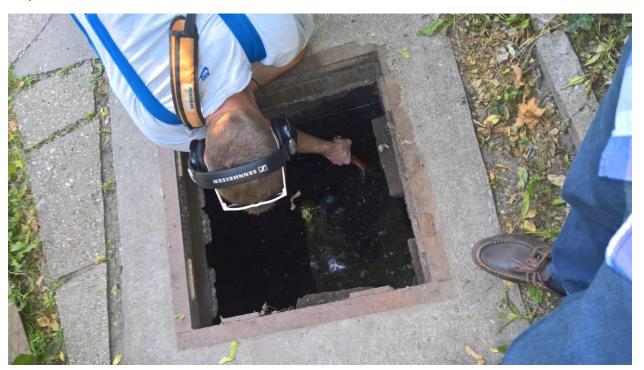
Suspected leak 00323

Utilis_ID	Crew#	Survey Date	Prime	Number	Street	City/Suburb	Postcode	Verified	Verified with UTILIS	Leak	Suspect	Quiet	Leak type	Pipe type	Estimated Leak Size [L/M]	Comments
00311	1	6/13/2017	No	27	Oszkó utca		1188	Yes	Yes	Х					0.03	
00323	1	6/13/2017	No	18	Arany János utca		1188	Yes	Yes	x					8.3	non-visible, due to the old rubble ring at the bottom of hydant
00378	1	6/13/2017	No	21	Zalán utca		1183	Yes	Yes			х				
00393	1	6/13/2017	No	42772	Kupa utca		1183	Yes	Yes			х				
01127	1	6/13/2017	No	13	Hurok utca	Budapest	1091	Yes	Yes		х					exist a water tank
01128	1	6/13/2017	No	12	Ifjúmunkás utca	Budapest	1091	Yes	Yes			х				
01146	1	6/13/2017	No	51A/D- 65A/D	Százados út	Budapest	1087	Yes	Yes			x				
01289	1	6/12/2017	No	84	Rézsű utca	Budapest	1029	Yes	Yes			х				
01292	1	6/12/2017	No	4b	Ábránd utca Ördögárok	Budapest	1029	Yes	Yes			х				
01293	1	6/12/2017	No	121	utca	Budapest	1029	Yes	Yes			x				
01295	1	6/12/2017	No	29	Táltos utca	Budapest	1029	Yes	Yes	х					1
